APPENDIX E

Bowstring Bridge Hydraulic Investigation Report

Hypothetical Meander Belt at Langstaff

Re: Hydraulic Analysis of Bowstring Bridge over Humber River for Vaughan Trail

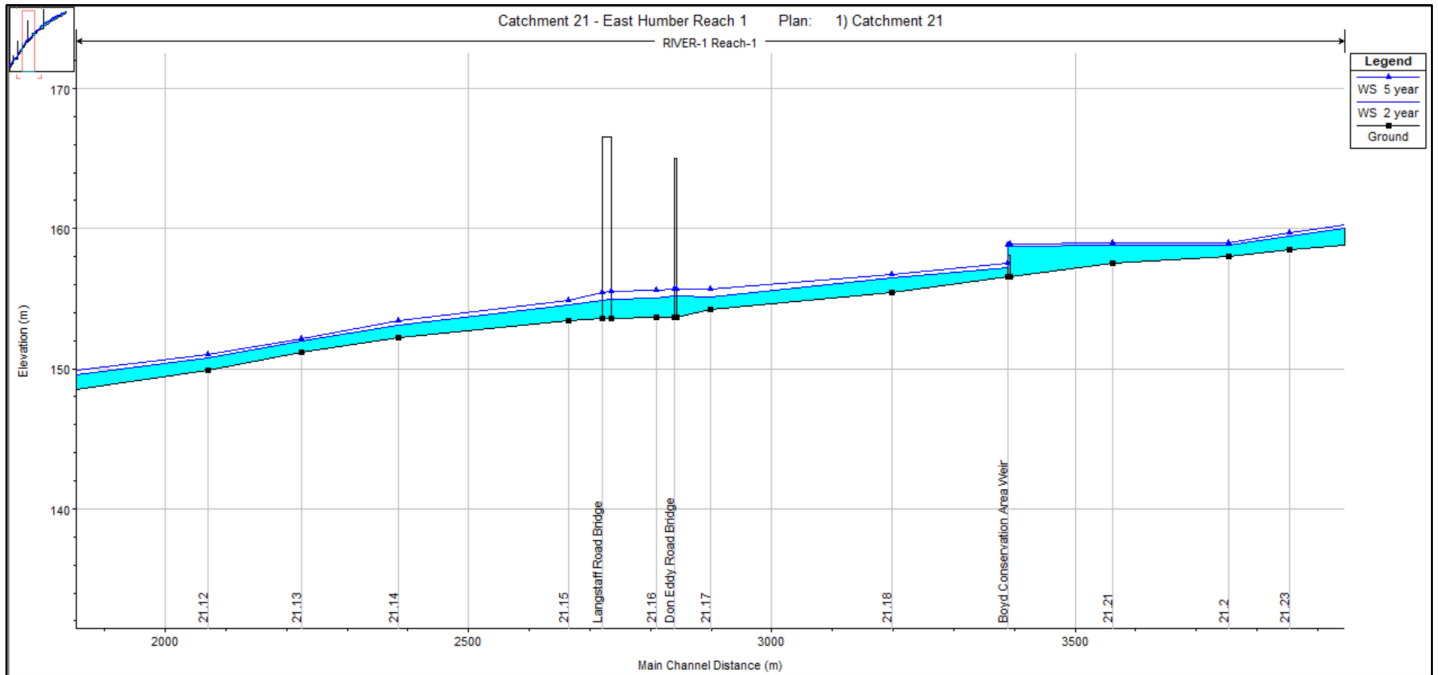
Figure 2. Water Surface Elevation Profile, 2 and 5 year return period.

Application of the model, referred to as **TRCA (Catchment 21, east_humber_21)**, provided insight into water surface elevations of the 2 & 5 year floods as shown in **Figure 2**. The cross section platform is illustrated in Figure 3, confirming the model is not georeferenced as per current TRCA standards, and mapping of flood level estimates requires engineering analysis of topographic information.

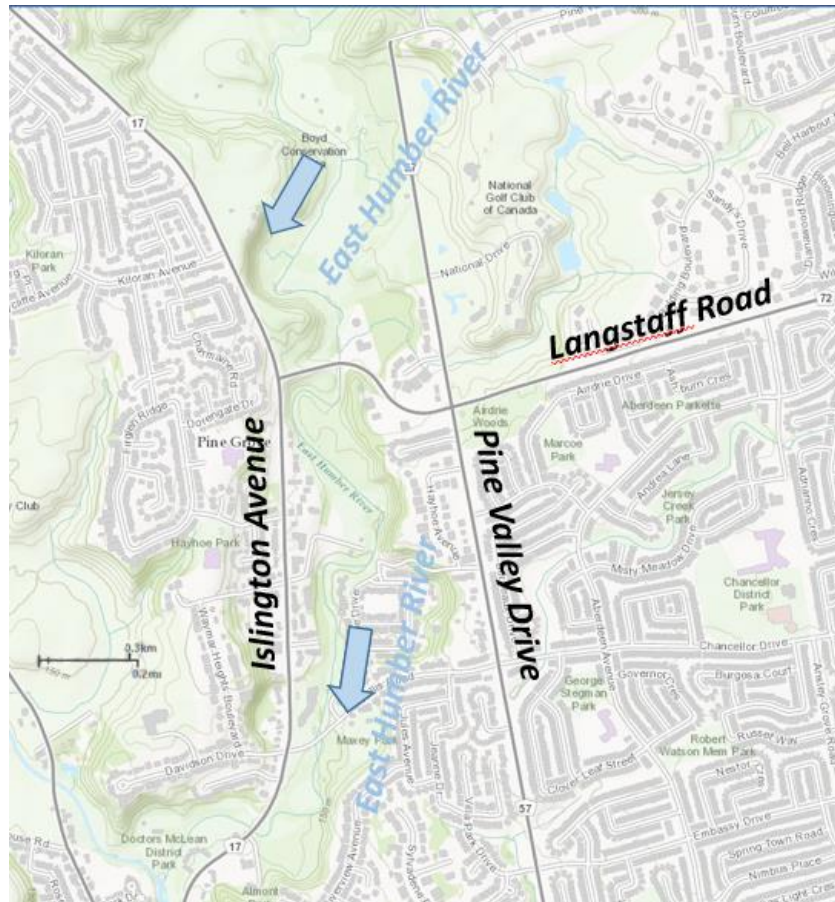
Figure 1 General Study Area Extents of Meandering Belt

Aquafor Beech was retained by Schollen & Company Inc. to complete a meander belt analysis for a segment of East Humber River, near Vaughan Humber Trail, in the city of Vaughan, Ontario. The site is bounded by Islington Ave. and Langstaff Rd.(Figure 1). The meander belt represents the area that a channel can reasonably be expected to occupy, both now and in the future, with respect to channel movement or migration. Meander belt delineation is one component considered in hazard mapping to define limits of development and is intended to not only protect natural channel processes within the study area, but also to protect private property and public health and safety.

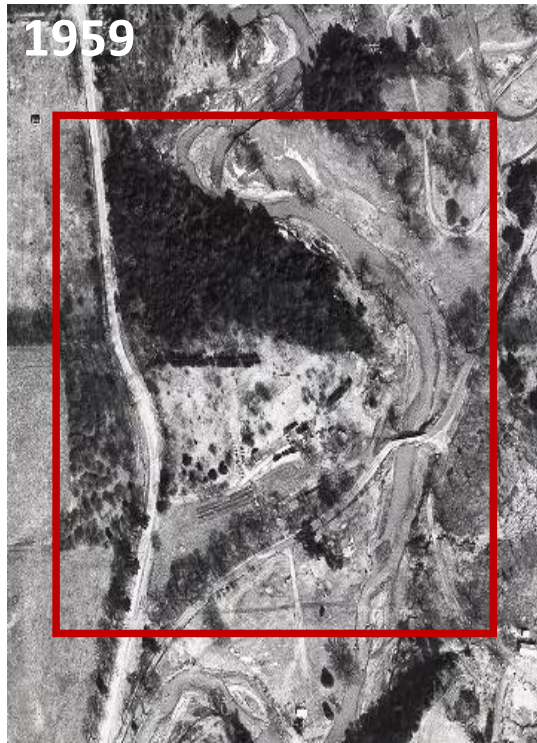
Figure 2 Historical Aerial Images of site in 1959

This study is high level meander belt assessment, which did not considered detailed assessment of historical images, but used them as reference a in identifying the meander pattern and axis for future. **Error! Reference source not found.**, Figure 3, Figure 4, and Figure 5 illustrates the historical change in the river planform as well as surrounding development. As can be seen in the figures below, the river course was straightened between the years 1959 and 1964. We can also see, a reduction in agricultural land, and the development of infrastructure during this time, which is indicated by parking lot construction. The site also has a bow string bridge, which is of historical importance, but is no longer in operation. From 1969 to 1975, there is no major change in river planform, or surrounding area.

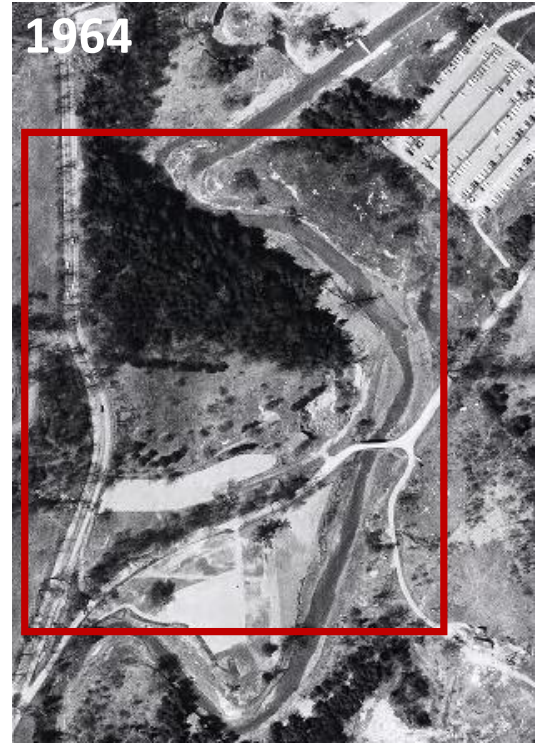
Figure 3 Historical Aerial Images of site in 1964

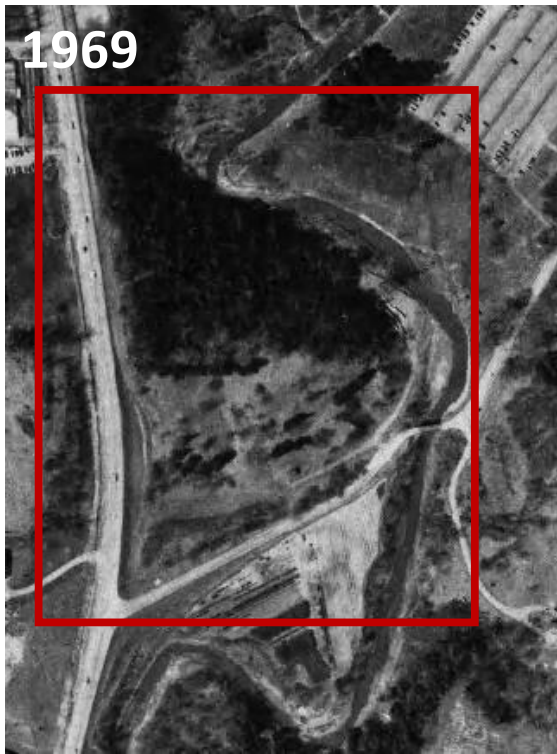
Figure 4 Historical Aerial Images of site in 1969

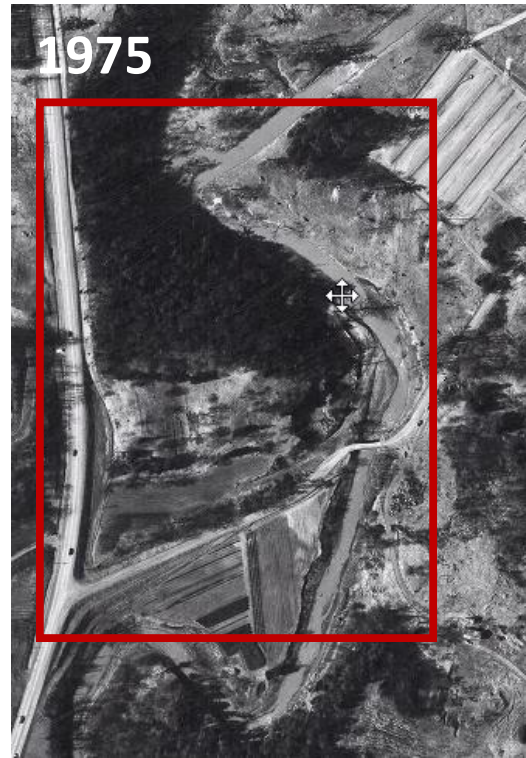
Figure 5 Historical Aerial Images of site in 1975
