# Vaughan Humber Trail

**Boyd Conservation Area  
to Steeles Avenue**

**Feasibility Study**

Schollen & Company Inc.

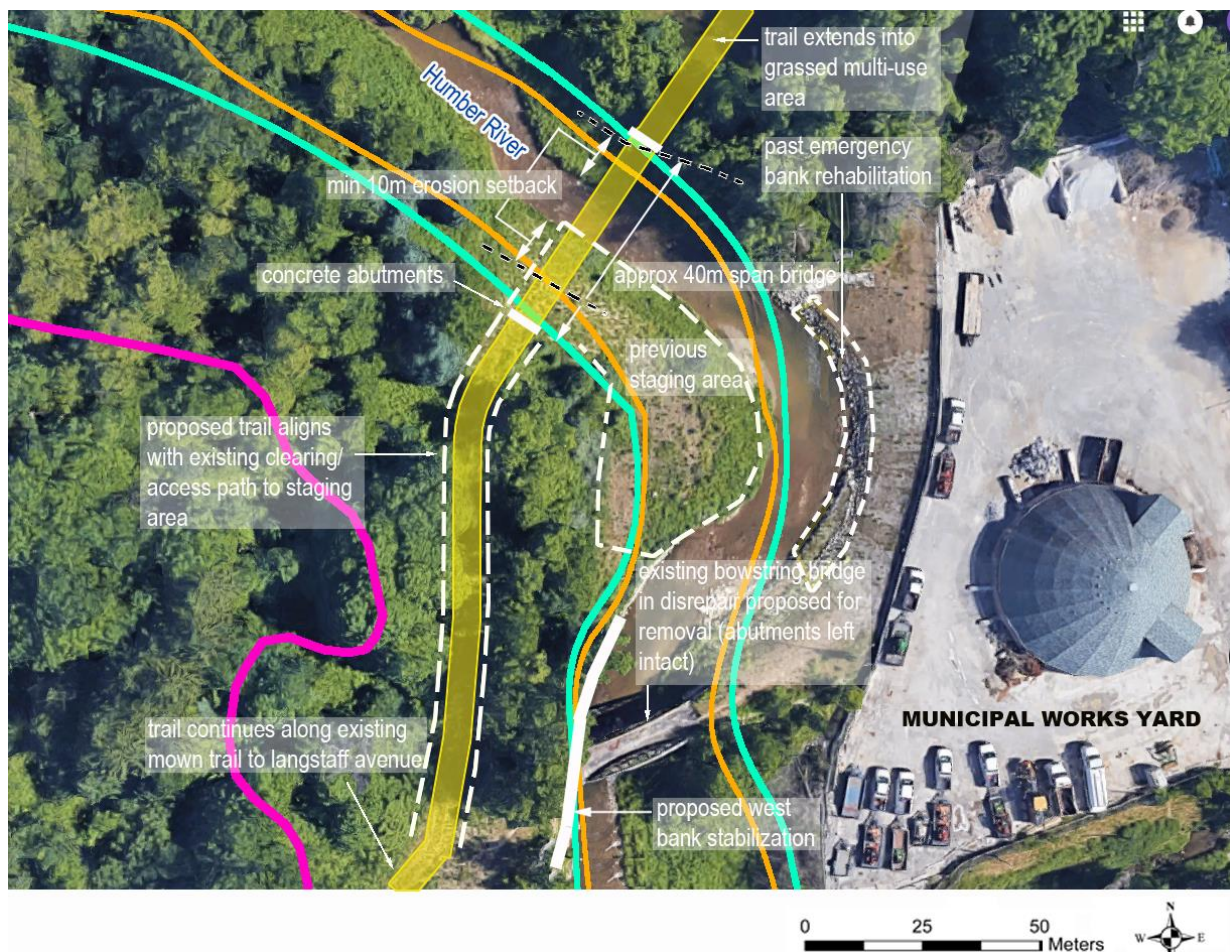
- A more direct connection to the picnic sites within the Conservation Area across the river;
- A favourable position away from the erosion-prone outer bend in the river, which is subject to greater erosion;
- Avoids potential conflict with the City Works Yard;
- Affords more space in which to adequately span the river to suit current regulations and best practices; and,
- Affords space in which to stabilize and restore the creek banks.

**Figure 6:** Focus Area 2 Concept Plan Enlargement

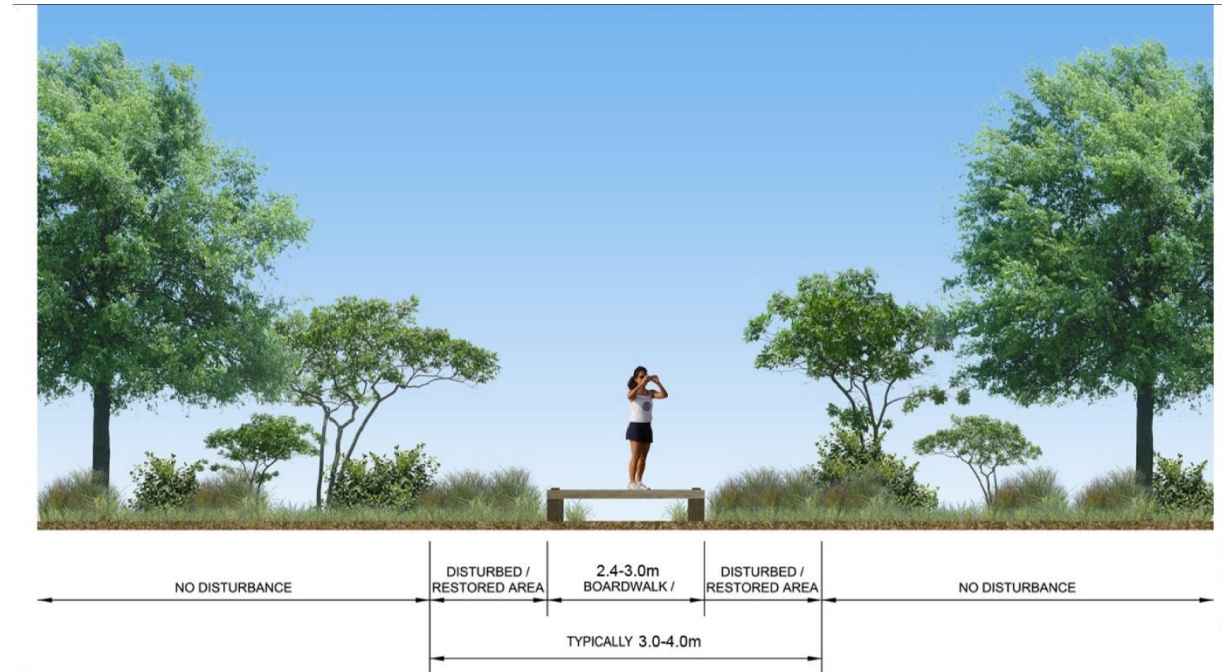
suitable width capable of accepting the loading of small maintenance or emergency vehicles (8 ton). The designs for boardwalks, railings and educational signage are to comply with AODA requirements.

**Figure 32:** Typical Boardwalk Cross Section

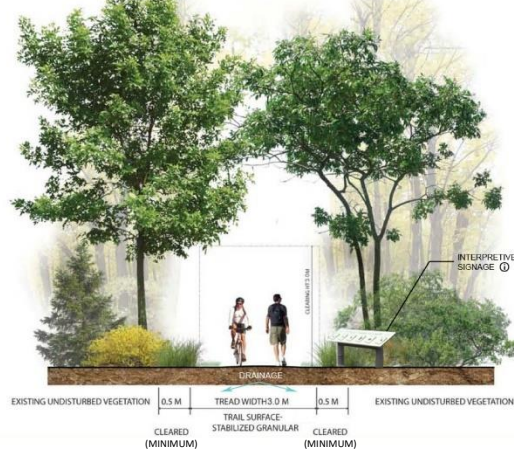
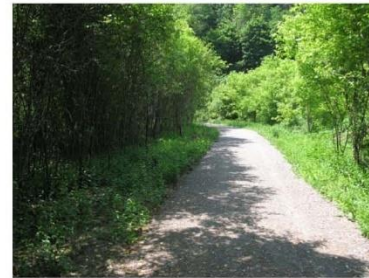
**Figure 34:** Typical Granular Nature Trail Cross Section
